Report No. UT-19.17

PERFORMANCE EVALUATION OF TYPICAL UDOT SURFACE TREATMENTS

Utah Department of Transportation
Research & Innovation Division

**Final Report
July 2019**

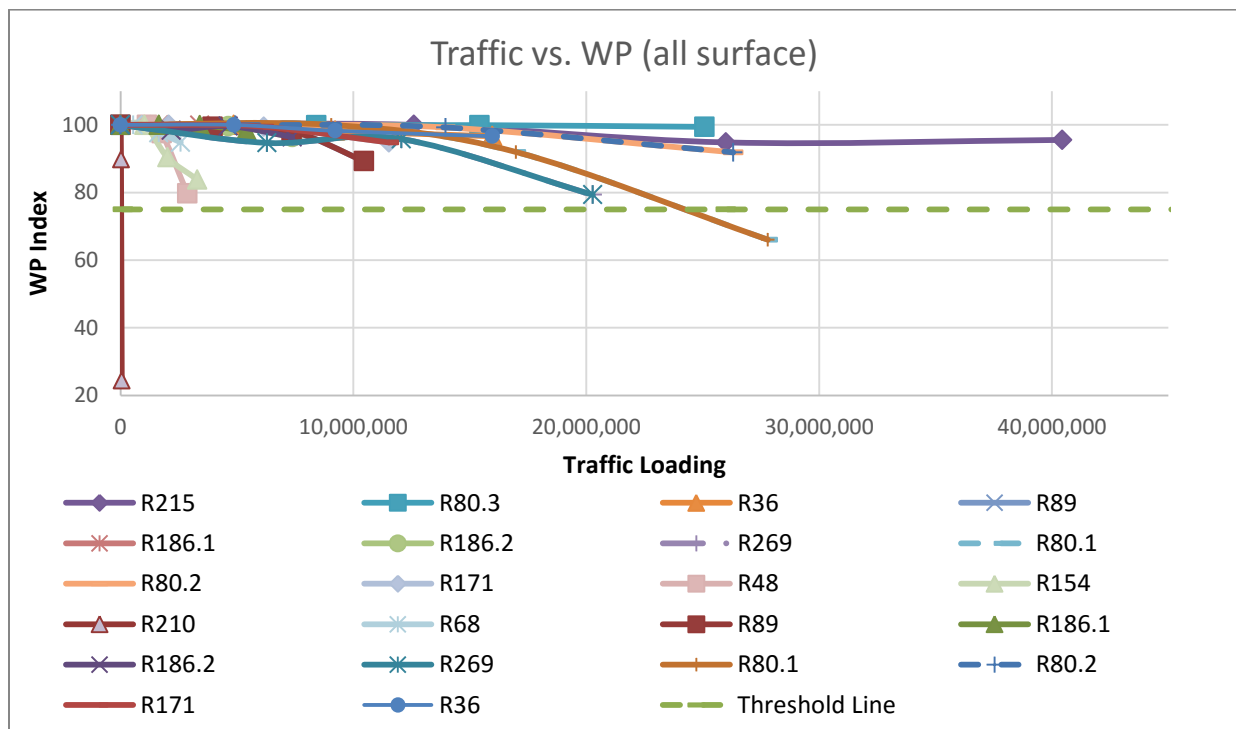
Figure 5-5. WP Index Summary Plot

According to the date and the traffic, the total WP index value versus traffic loading counts for all 14 TLT treatment sections in each observation year were plotted. In general, the results follow the expected curve of the pavement performance versus traffic. This is shown in Figure 5-5

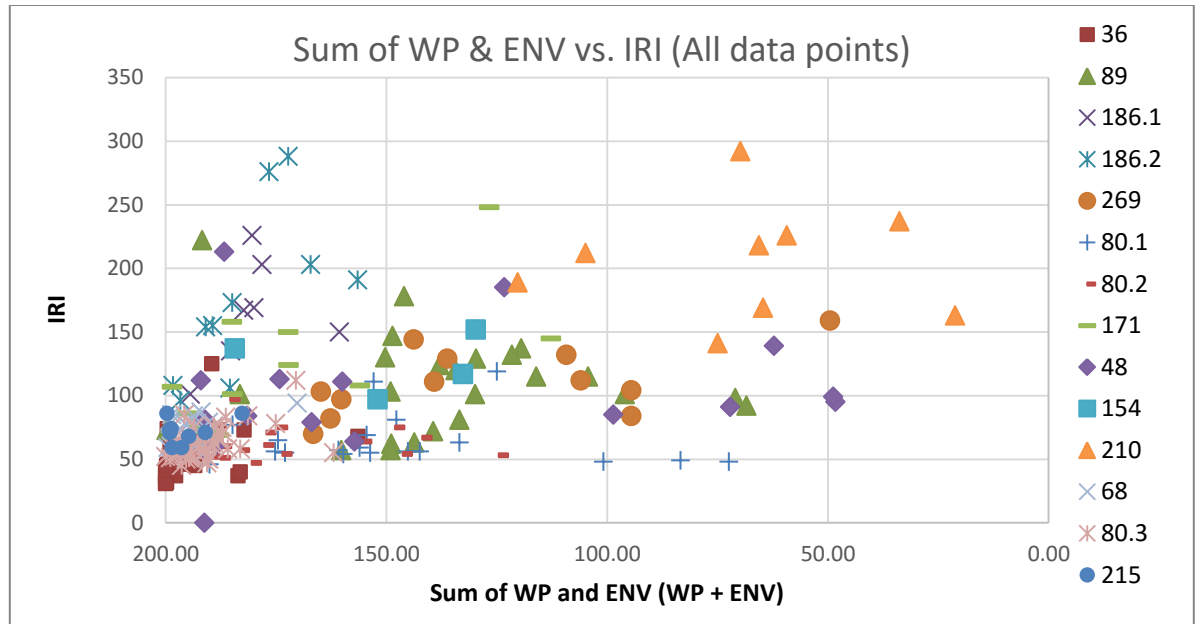
Figure 5-9. IRI Data Summary Plot

Figure 5-9 shows the relation between IRI and the sum of WP + ENV. The IRI value is expected to increase when the amount of distress increases and the total distress should be the total number of ENV and WP. However, as can be seen, there is not a clear trend. Different TLT sections have different behavior. No obvious trend or rule can be found from this plot.

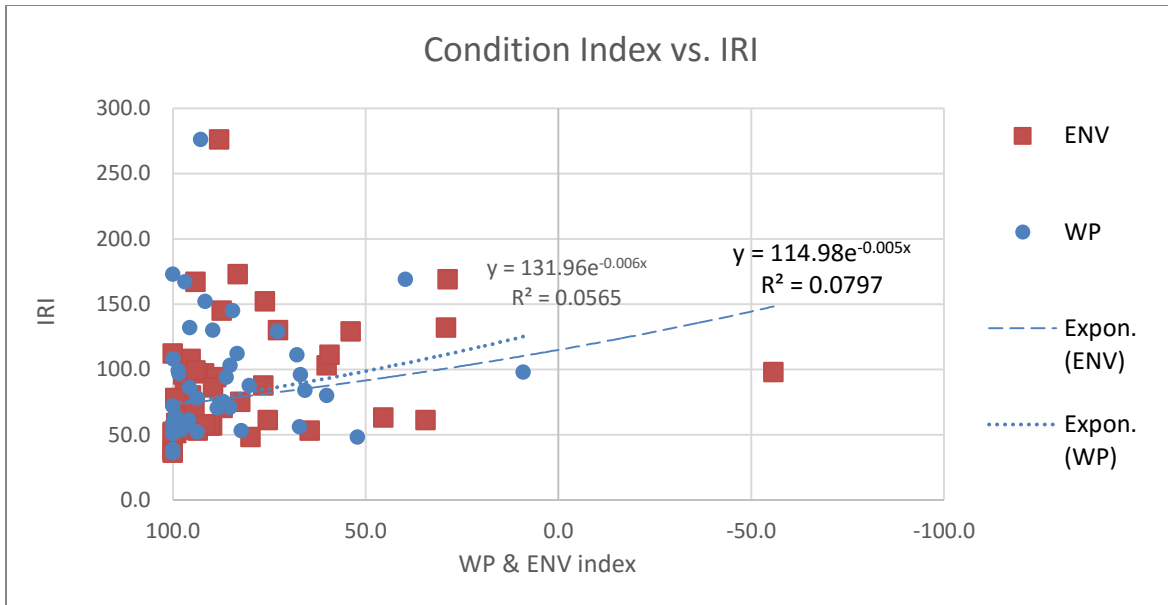
Figure 5-10. TLTs' IRI Data Plot

The correlation coefficient (R^2) between the IRI and Surface Condition Index was determined for WP, ENV, and ENV+WP. As shown in Figure 5-10, the correlation coefficient is below 0.08. The result of the correlation study indicates that the IRI does not account for or capture the effect of all distresses. For example, cracking is counted based on width, so unless faulting were to occur, such distresses would not make a significant difference in the IRI. The large spread area and high concentration of points on the good condition side cannot give the relationship function for IRI and condition index, so the surface condition indices may not relate to IRI. In other words, unlike what some literature has mentioned, one value cannot be used as a predictor of the other or as an alternative to the other.

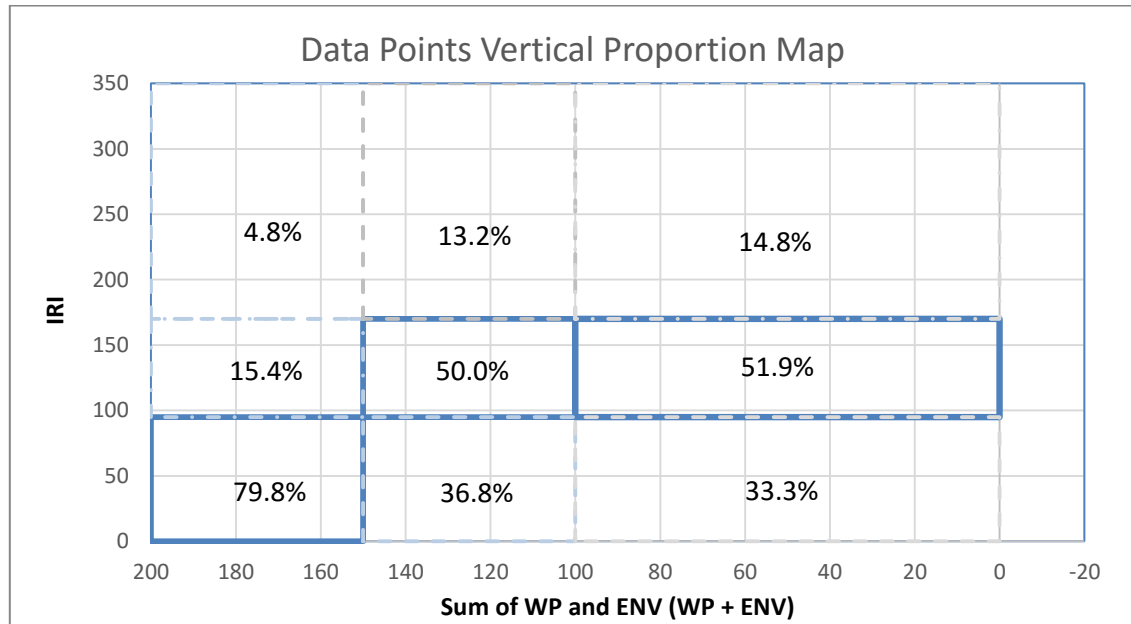
Figure 5-11. IRI Data Points Concentration Plot

The IRI data points proportion was calculated based on each condition level. In good condition WP+ENV is greater than 150 and 79.8% of the sections have an IRI less than 100; in other words, it can be said that a section with $WP+ENV > 150$ has an 80 percent change of being smooth ($IRI < 100$). When the WP+ENV is between 150 and 100, 50% sections have an IRI between 95 and 170, which is “Failed”; in other words, if the $150 < WP+ENV < 100$ there is a 50% probability that the $95 < IRI < 170$. Finally, if the WP+ENV is less than 100, 67% of the sections will have an IRI greater than 100 and only about 33% of the sections have the IRI less than 95. While this does not necessarily represent causation, it would be expected that those sections having a high WP+ENV index (i.e., have few distresses) will have lower roughness. This is shown graphically in Figure 5-11.

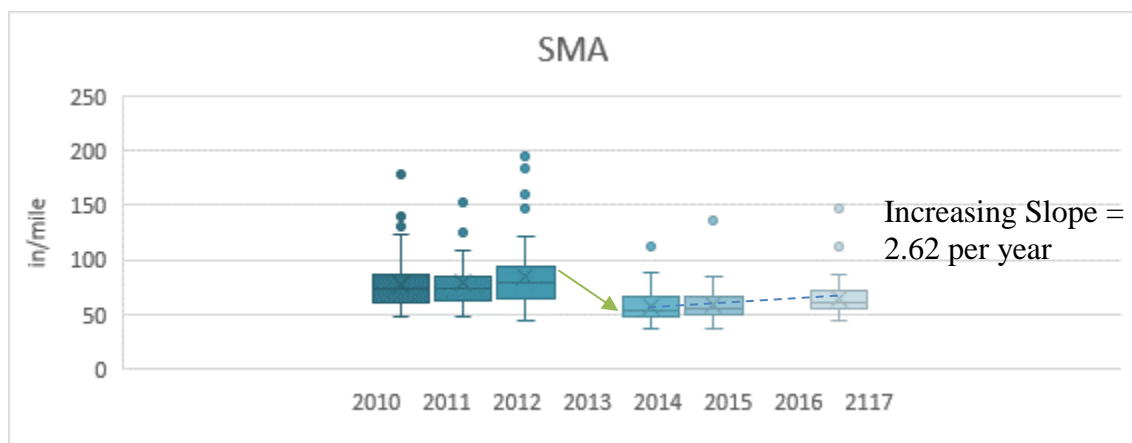
Figure 5-12 SMA IRI Box Plot

The IRI plot of the SMA treatment, Figure 5-12, shows the clearest trend. It shows an increase in IRI with time (2010-2012) then a drop after the treatment (2012-2013) followed by a small increase of 2.62 in/mile per year with time (2014-2017). SMA treatment only consists of two roads, so no significant conclusions are made.

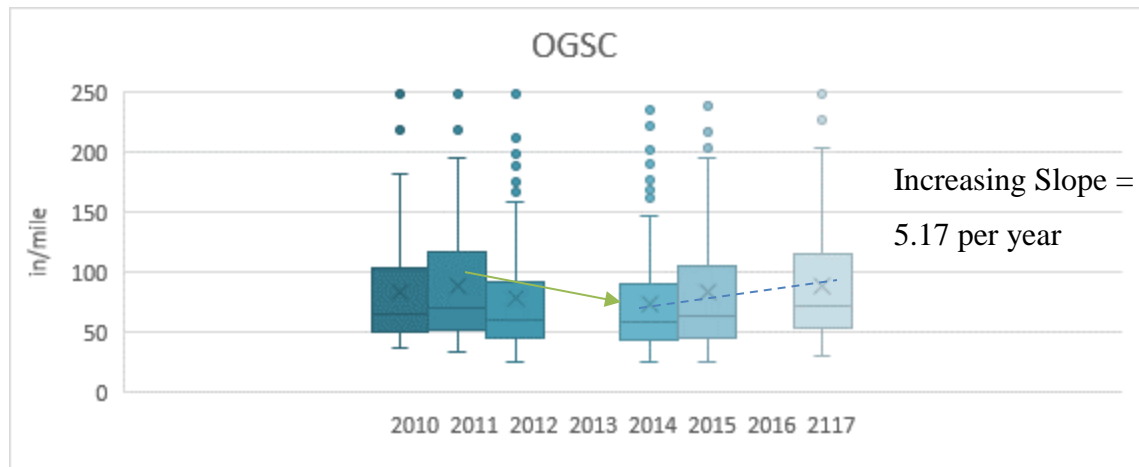
Figure 5-13 OGSC IRI Box Plot

OGSC surface has a larger data set when compared to the other two treatments. As shown in Figure 5-13, the surface conditions of all OGSC sections have lower IRI on both average and data range after they received the TLT in 2012, but less concentrated data points indicate the big variability of the OGSC IRI data. Also, a constantly increasing trend of the OGSC roughness index of 5.17 in/mile per year is found from year 2014 to 2017.

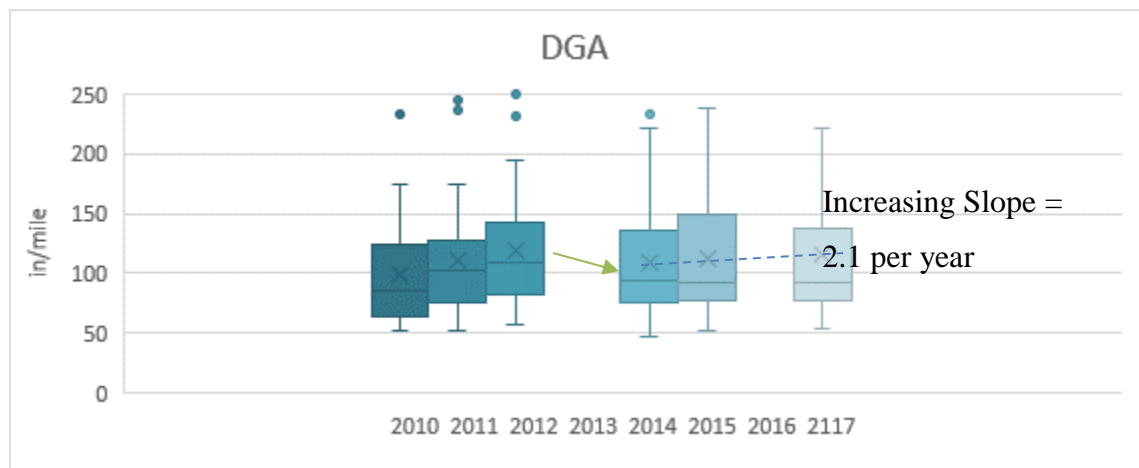
Figure 5-14 DGA IRI Box Plot

As seen in Figure 5-14, DGA IRI is the highest value out of three TLTs' results, starting above 100 after the treatment. The DGA surface also shows better improvement from the treatment as reflected by an IRI drop from 2012 to 2014. The roughness number increased from 2014 to 2017 at a rate of 2.1 in/mile per year, which is less than the other treatment; however, the IRI values are, as a whole, higher than other surfaces.

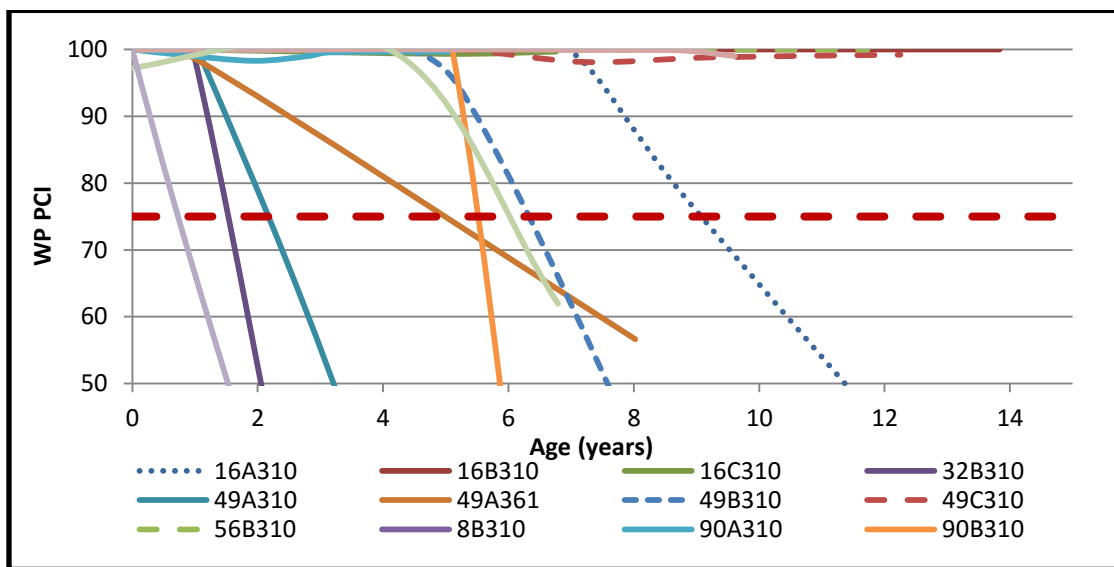
Figure 6-1, Wheel-path pavement condition index with failure line.

Two plots were made, one for WP and one for ENV distresses. These plots are shown in Figures 6-1 and 6-2, respectively. Out of the 16 sections, seven appear to be failing for WP cracking. Figure 6-2, ENV index versus age, shows some interesting behavior in the measurement of the ENV index for the sections. For instance, on section 8B310 the ENV index dips below 70 after one year and picks back up to 76 half a year later. Other sections that experienced this same behavior were 90A310, 8A310, and

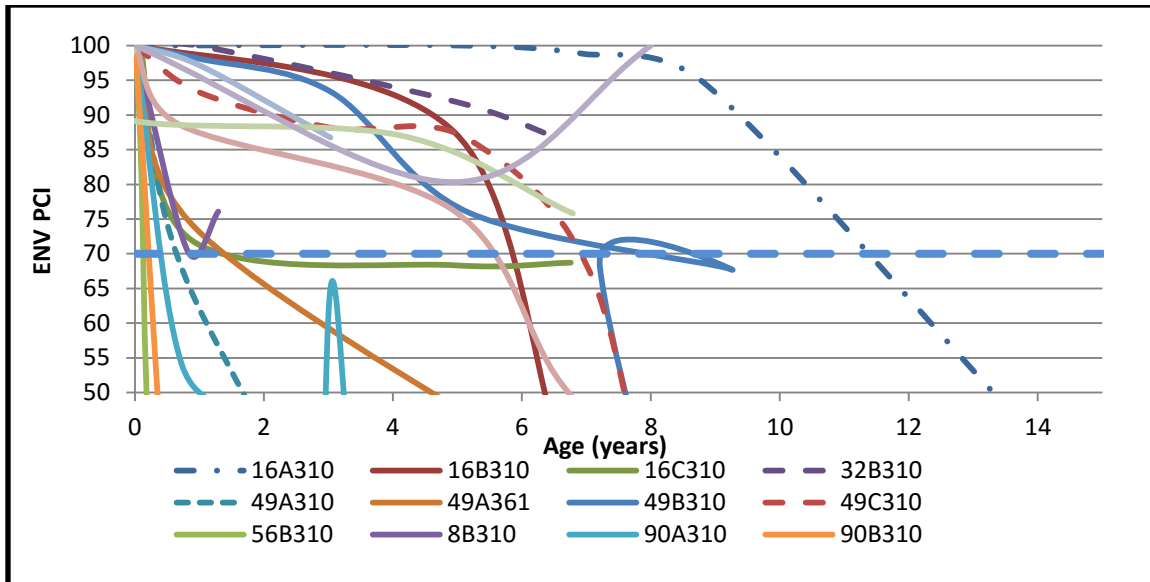
Figure 6-2, Environmental pavement condition index with failure line.

49B310. This could possibly be attributed to self-healing of thermal distresses or it's possible the evaluator rated the distress types differently over the survey time period. Self-healing is the closure of cracks due to the liquid behavior of asphalt which increases at higher temperatures (Little and Bhasin 2007). Out of the 16 sections, ten appear to be failing for ENV distresses. This high number may be an indication of the Marshall Mix design method not considering temperature effects in binder selection.

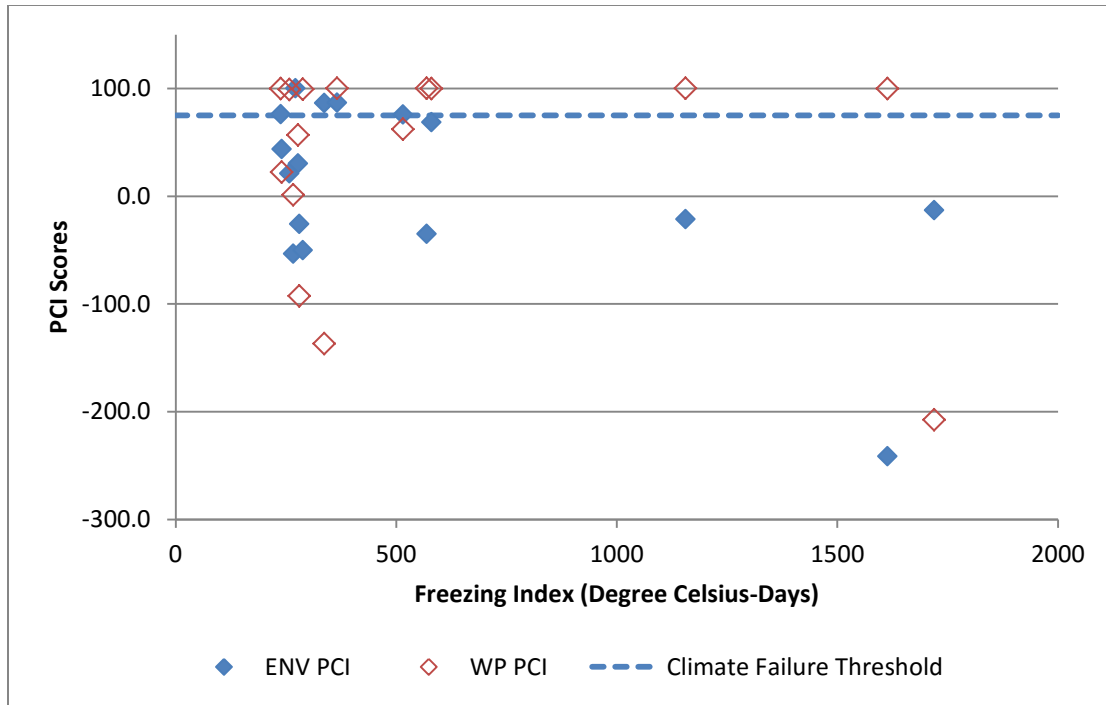
Figure 6-3. LTPP pavement condition indices and freezing index.

The effect that temperate and climate had on these overlay treatments was substantial. Obviously, colder climates will exacerbate distress formation. In order to show this, the ENV and WP indices for each route were plotted in Figure 6-3 against the annual freezing index for these sections. The freezing index, as defined by the National Snow & Ice Data Center, is the total annual number of degree-days when temperatures are below zero degrees Celsius. Noticeable from Figure 6-3 is the general downward trend in the ENV index scores with increasing freezing index. For the WP index, this trend is not noticeable as the data is more scattered. However, as ENV cracking increases it is expected for WP cracking to increase proportionately. This is primarily from increased water ingress into the pavement and subsequent structural damage to supporting layers.
